Re: **Administrative Docket No. CWA-02-2016-3036**
GMD Shipyard Corp., SPDES Tracking No. NYR00D162
Clean Water Act Administrative Compliance Order

**ADMINISTRATIVE
COMPLIANCE ORDER**

CWA-02-2016-3036

Compliance Evaluation Inspection: GMD Shipyard Corp.	
Inspection Date: February 26, 2016	EPA Inspector: Kimberly McEathron, Physical Scientist, USEPA Region 2, (212) 637-4228
Inspection Time: 9:45 AM – 11:30 AM	
On-Site Representative: Kevin Nugent, Director of Health, Safety and Environment, GMD Shipyard Corp., (718) 260-9200	
Site Information:	Lat / Long: 40.700, -73.969 GMD Shipyard Corp. Brooklyn Navy Yard BLDG. 595 63 Flushing Avenue Unit #278 Brooklyn, NY 11205 SPDES/ICIS No. NYR00D162
SIC Code:	3731 – Ship Building and Repairing

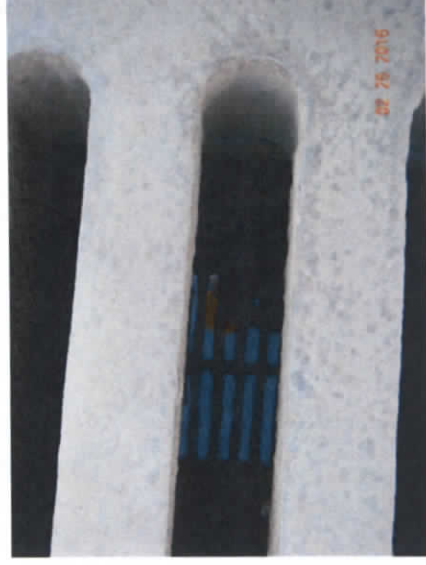
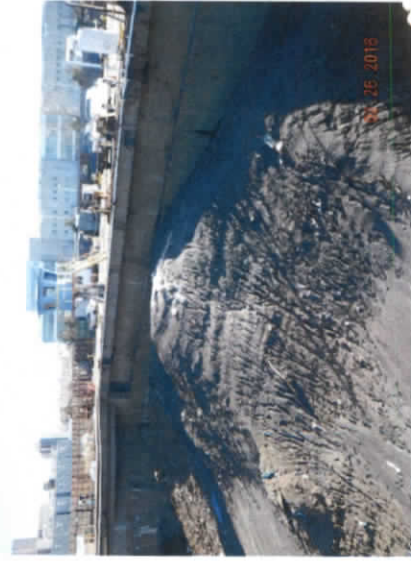
DSCN6637

4. At the time of the inspection, EPA inspector McEathron observed at least three (3) catch basins where the fabric was out of place or removed at the time of the inspection (see photographs DSCN6637.JPG – DSCN6638.JPG, DSCN6644.JPG and DSCN6684.JPG – DSCN6687.JPG).

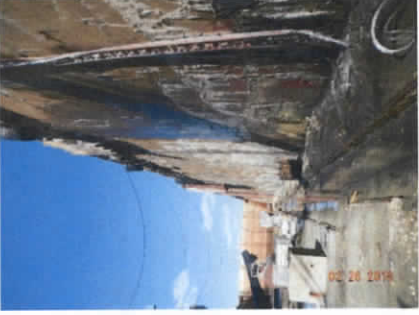
DSCN6651

- iii. At the time of the inspection, EPA inspector McEathron observed spent grit, debris and waste in the north and south drainage channels and along the floor of Dry Dock 5 (see photographs DSCN6651.JPG – DSCN6657.JPG and DSCN6660.JPG – DSCN6664.JPG) and Dry Dock 6 (see photographs DSCN6694.JPG – DSCN6697.JPG and DSCN6699.JPG – DSCN6708.JPG).

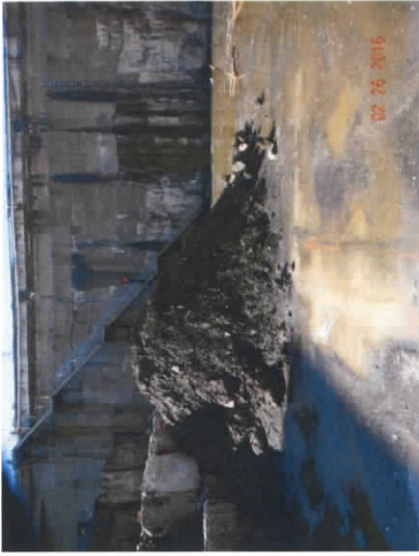
DSCN6658

- i. A large pile of spent grit, soil, sediment, trash and other materials in the southeast end of Dry Dock 5 (see photographs DSCN6642.JPG and DSCN6657.JPG – DSCN6658.JPG). According to the Facility representative, this pile has been at this location for over fifteen (15) years. Therefore, the material has not been removed when the dry dock is flooded and the material is completely submerged with water. This pile appeared to be only slightly smaller than when EPA first observed the pile at the time of the May 14, 2014 CEI;

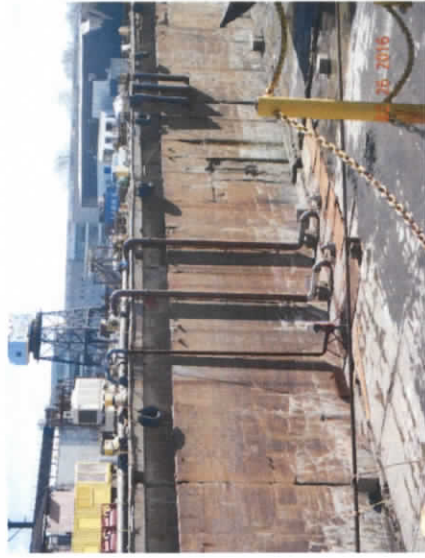
DSCN66675

DSCN6674.JPG	Outfall 006 outfall sign
DSCN6675.JPG	Along caisson door, water flowing in from across the dry dock from apparent leak
DSCN6676.JPG	1 new small pump and 2 large submersible pumps on north side of dry dock No. 5

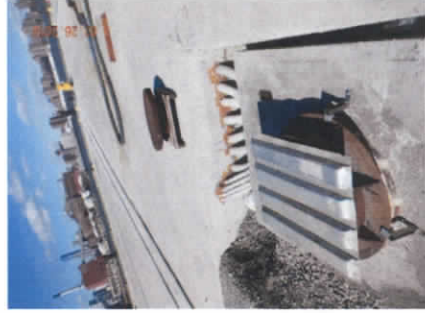
DSCN6677

Berth 8A	
DSCN6677.JPG	Newly constructed and paved Berth 8A
DSCN6678.JPG	Upstream manhole
DSCN6679.JPG	Catch basin
DSCN6680.JPG	Close up of catch basin
DSCN6681.JPG	Catch basin with broken frame
DSCN6682.JPG	Close up of catch basin with broken frame
DSCN6683.JPG	Catch basin with broken frame
DSCN6684.JPG	Uncovered catch basin with standing water adjacent to spent grit pile remnants
DSCN6685.JPG	Uncovered catch basin with standing water adjacent to spent grit pile remnants
DSCN6686.JPG	Uncovered catch basin with standing water adjacent to spent grit pile remnants
DSCN6687.JPG	Another catch basin close up
DSCN6688.JPG	Uncovered catch basin with standing water adjacent to spent grit pile remnants
DSCN6689.JPG	Uncovered catch basin with standing water adjacent to spent grit pile remnants
DSCN6690.JPG	Catch basin close up
DSCN6691.JPG	Manhole lid cover
Berth 9	
DSCN6692.JPG	Spill kit
DSCN6693.JPG	Berth 9
Dry Dock No. 6
